# Impact Testing on Reinforced Carbon-Carbon Flat Panels With Ice Projectiles for the Space Shuttle Return to Flight Program

*Matthew E. Melis, Duane M. Revilock, and Michael J. Pereira  
Glenn Research Center, Cleveland, Ohio*

*Karen H. Lyle  
Langley Research Center, Hampton, Virginia*

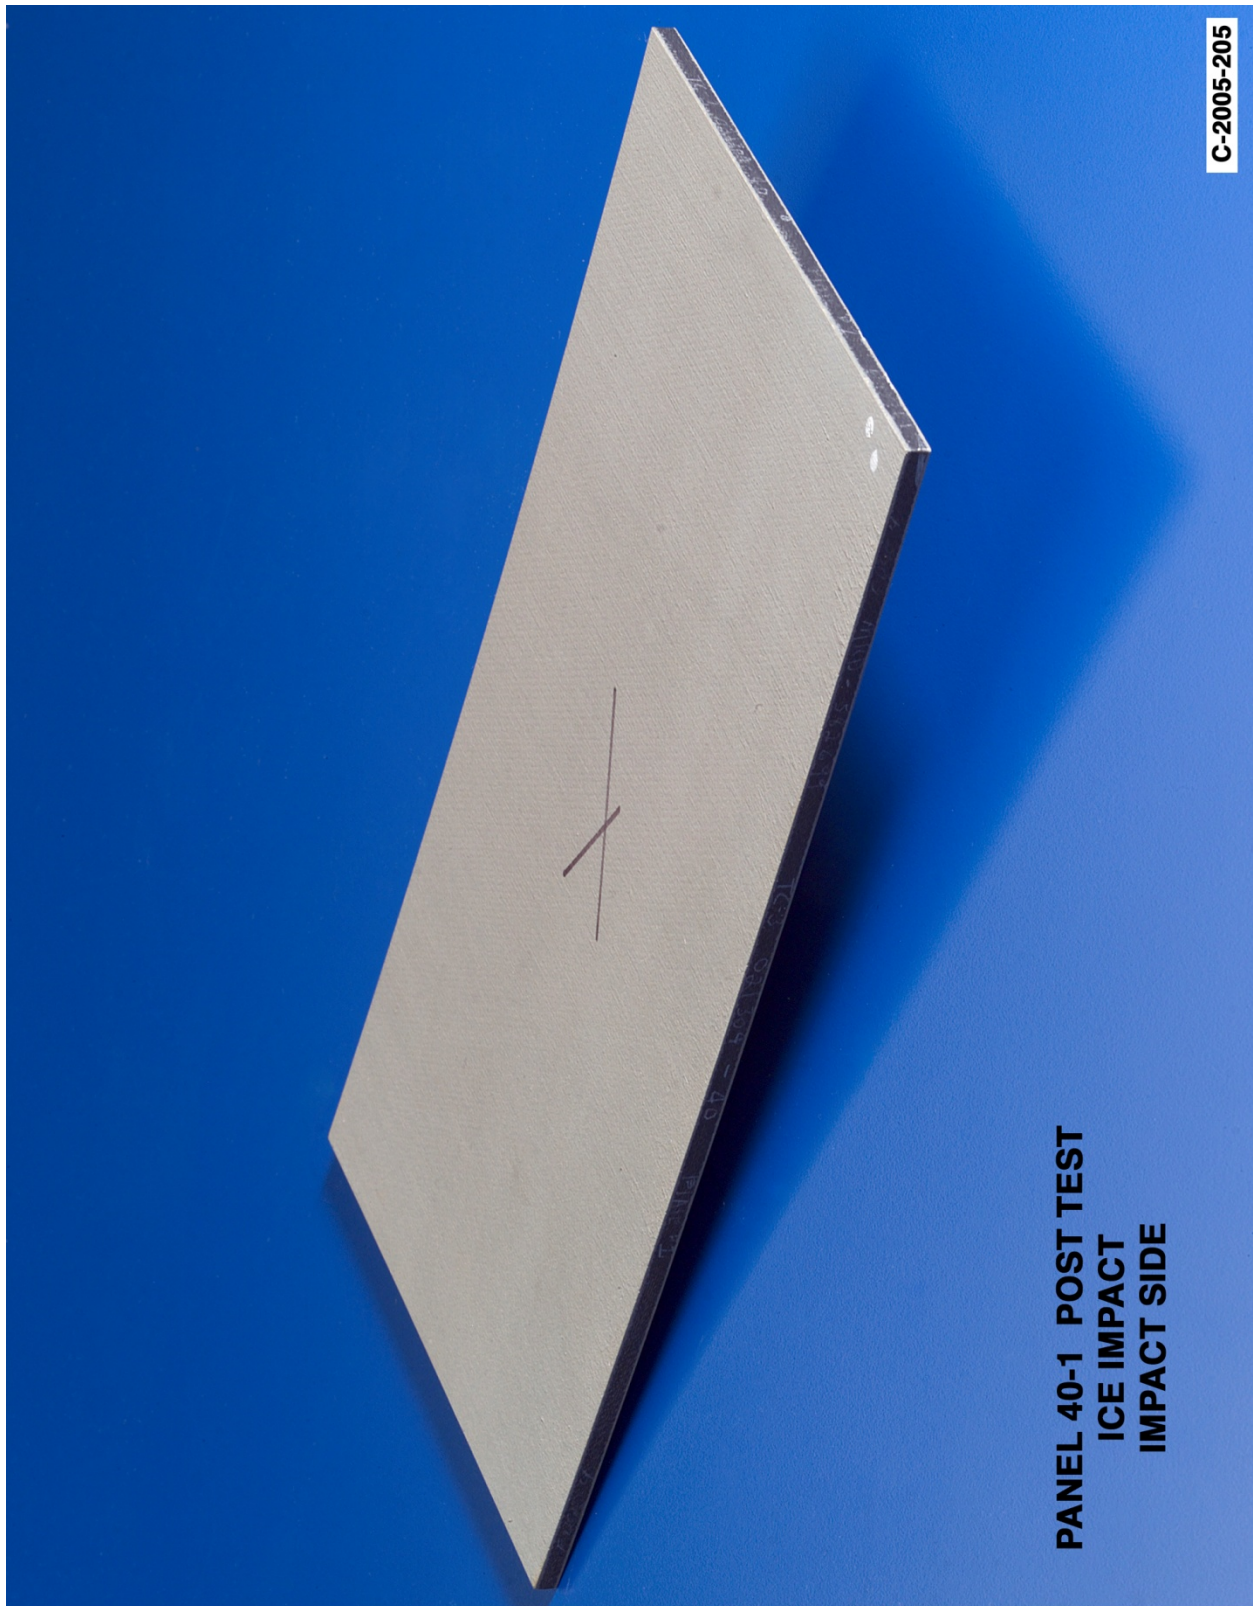
Figure C6-2.—Front (impact side) of panel 40-1 at 319 ft/s with a high-density, poly-crystal ice cylinder (nominally 0.66 in. in diameter by 1.66 in.) at 90° impact angle. Test GRCC 157.

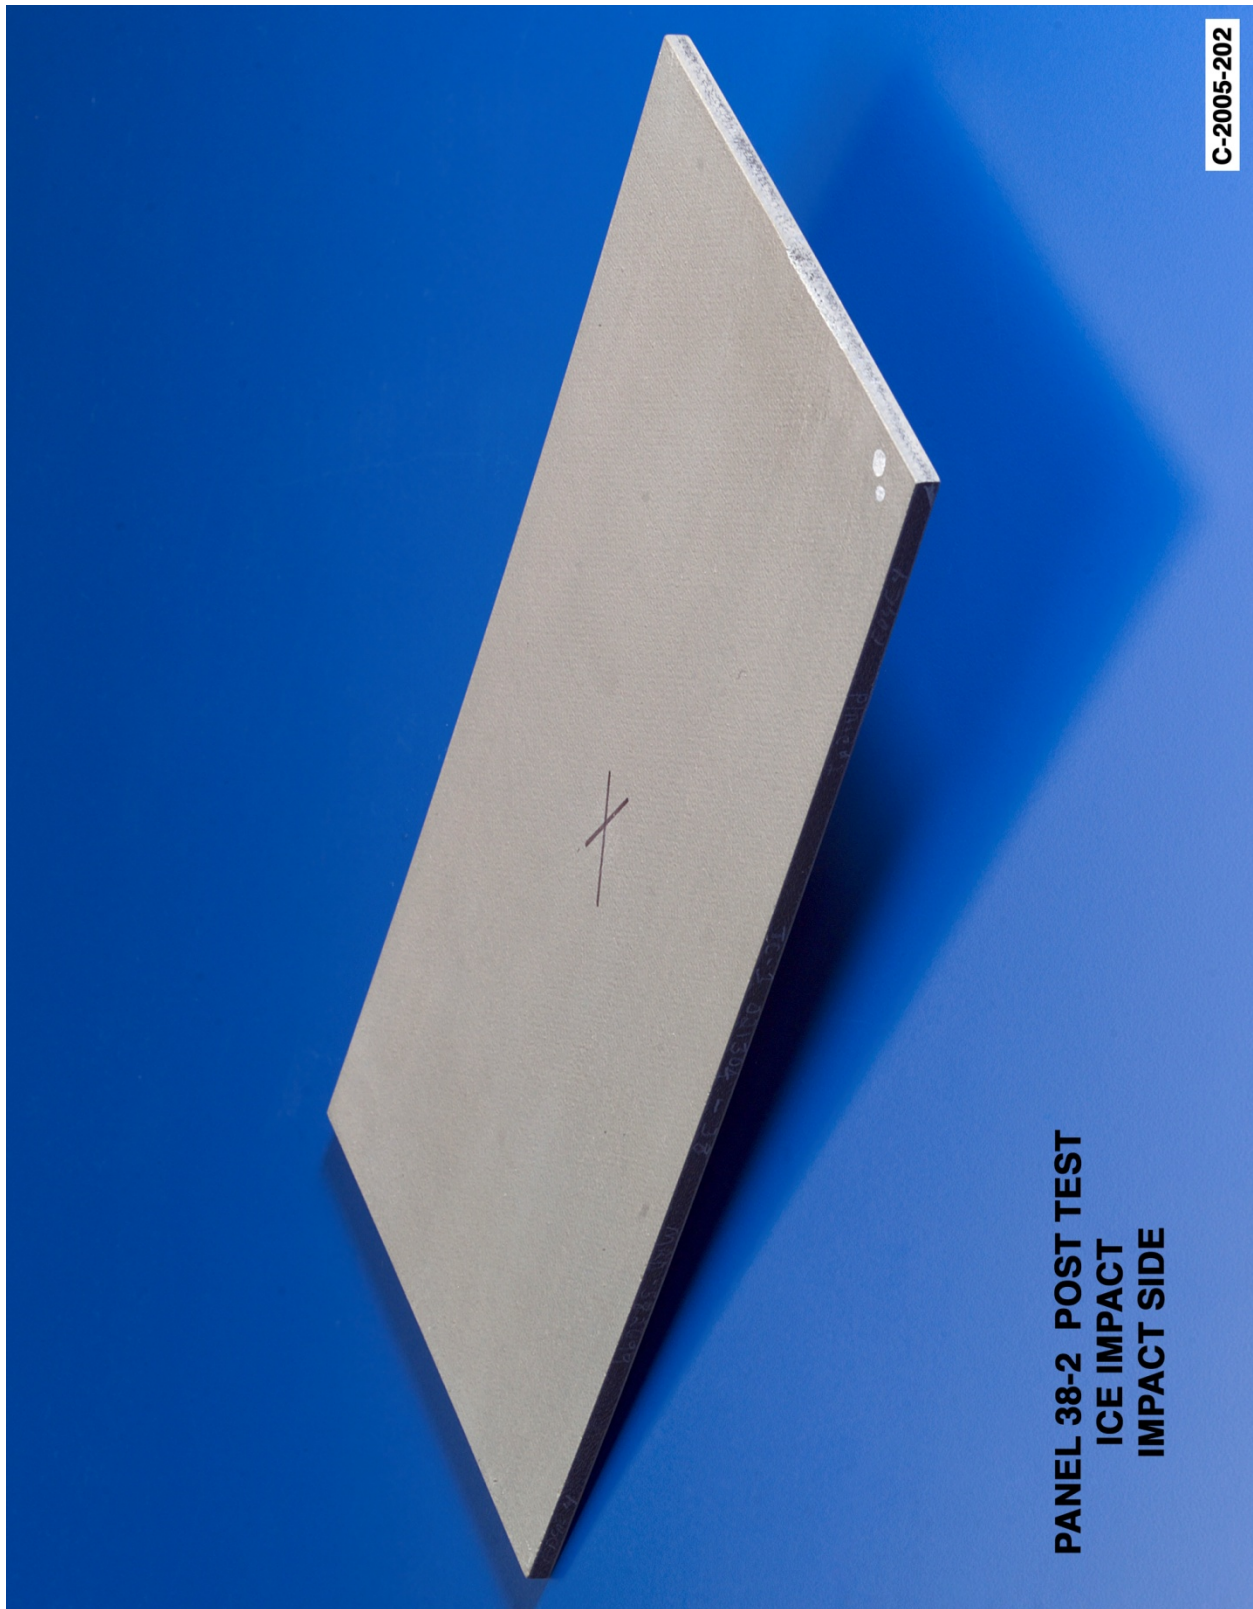
Figure C7-2.—Front (impact side) of panel 38-2 at 350 ft/s with a high-density, poly-crystal ice cylinder (nominally 0.66 in. in diameter by 1.66 in.) at 90° impact angle. Test GRCC 156.

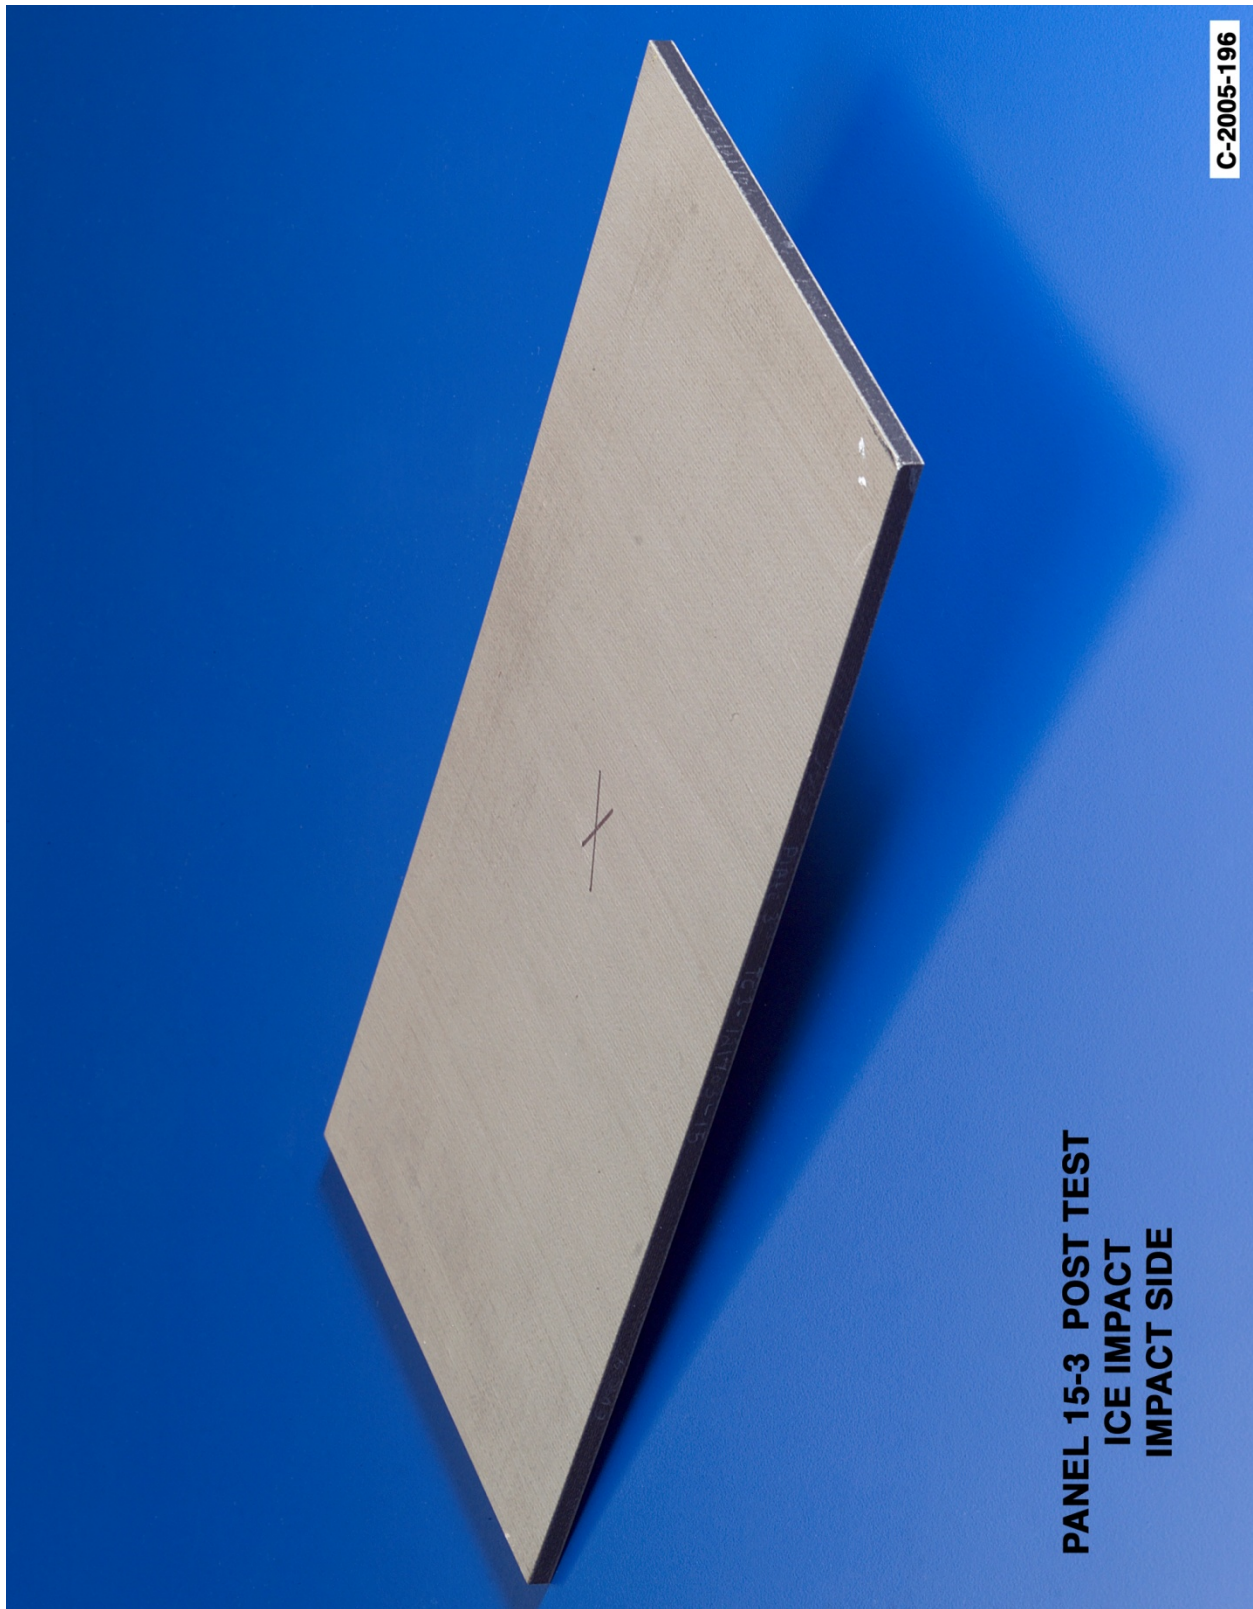
Figure C8–2.—Front (impact side) of panel 15-3 at 398 ft/s with a high-density, poly-crystal ice cylinder (nominally 0.66 in. in diameter by 1.66 in.) at 90° impact angle. Test GRCC 154.

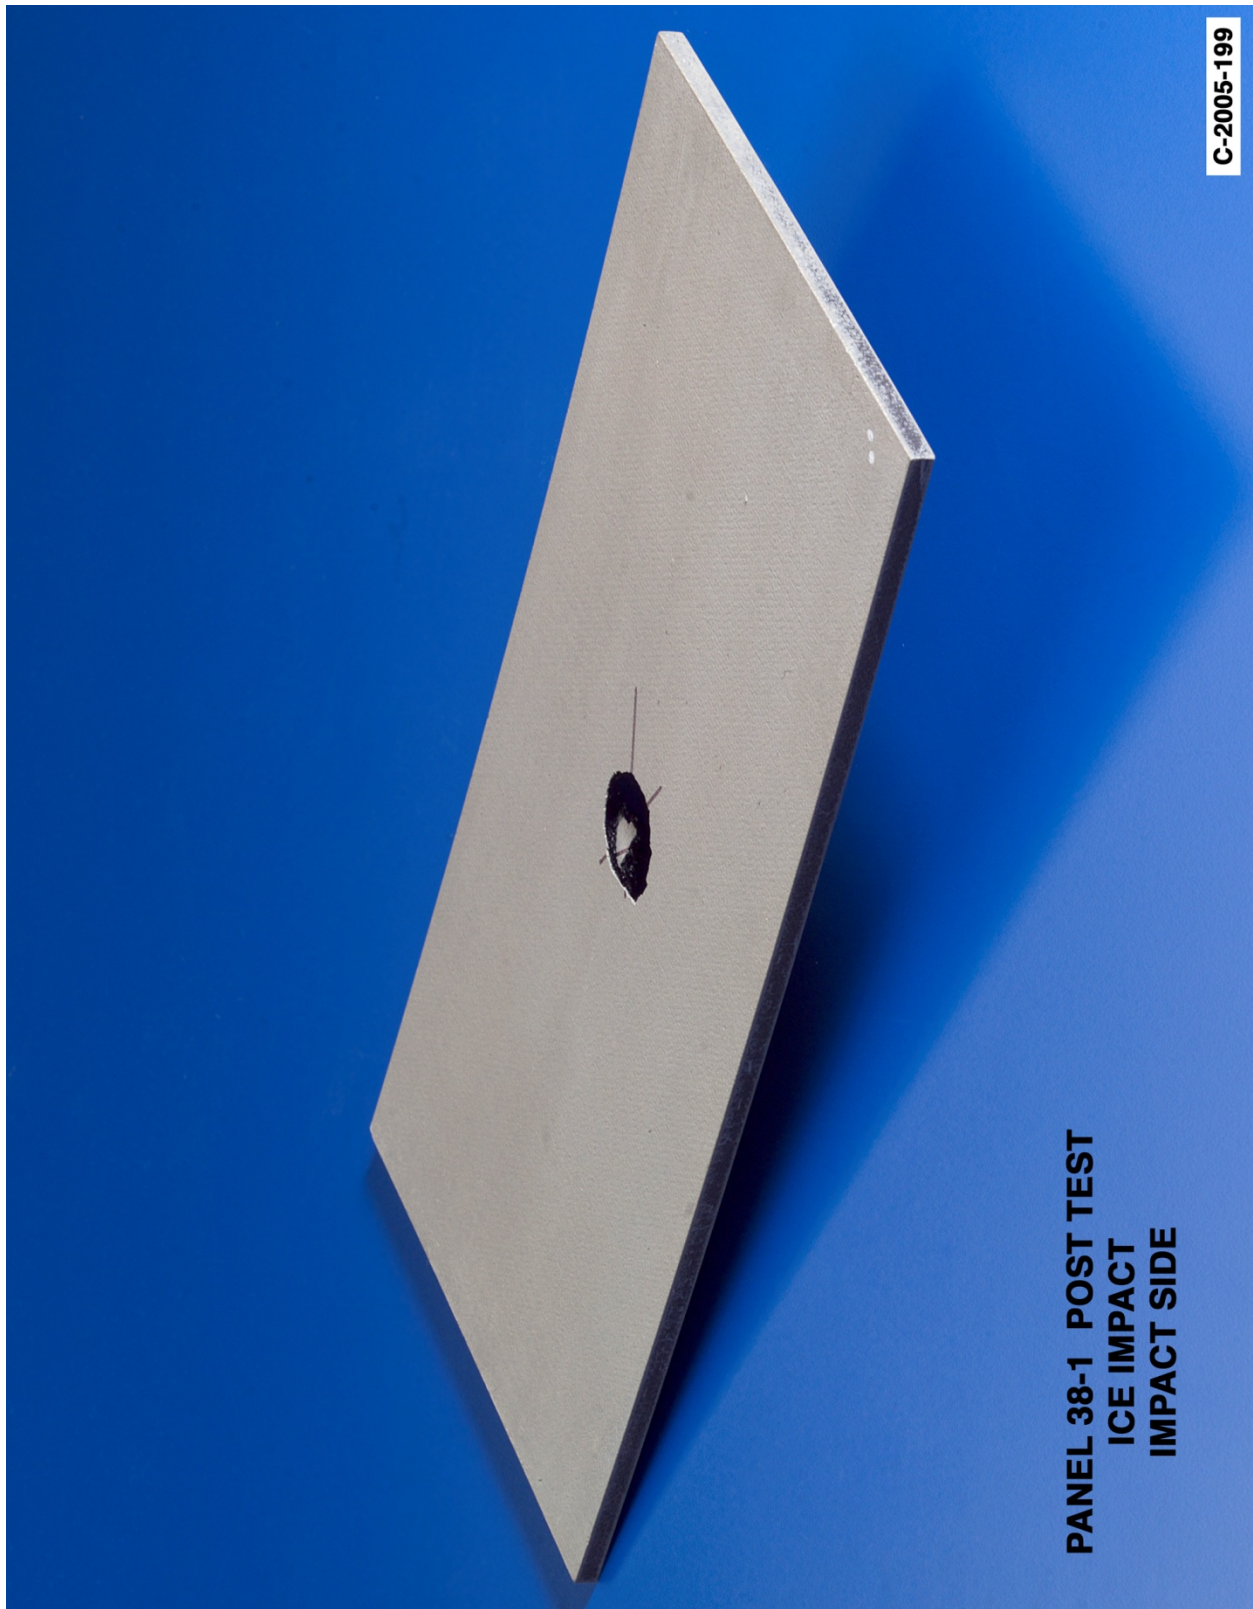
Figure C9-2.—Front (impact side) of panel 38-1 at 616 ft/s with a high-density, poly-crystal ice cylinder (nominally 0.66 in. in diameter by 1.66 in.) at 90° impact angle. Test GRCC 155.
